**COLORADO  
COLLEGE**

## 2019 ENERGY REPORT

October 2019

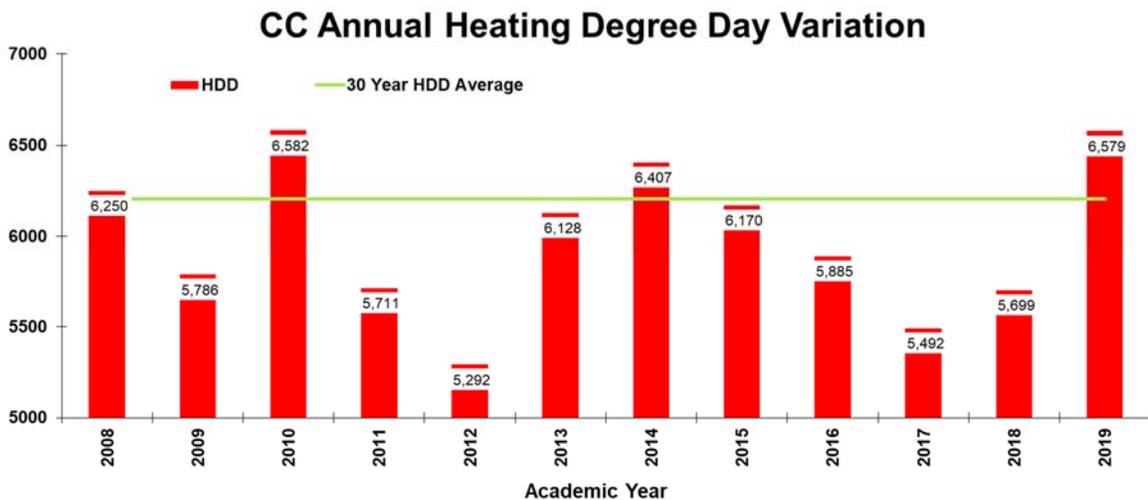
- Colder than average winter conditions depicted in the chart below:

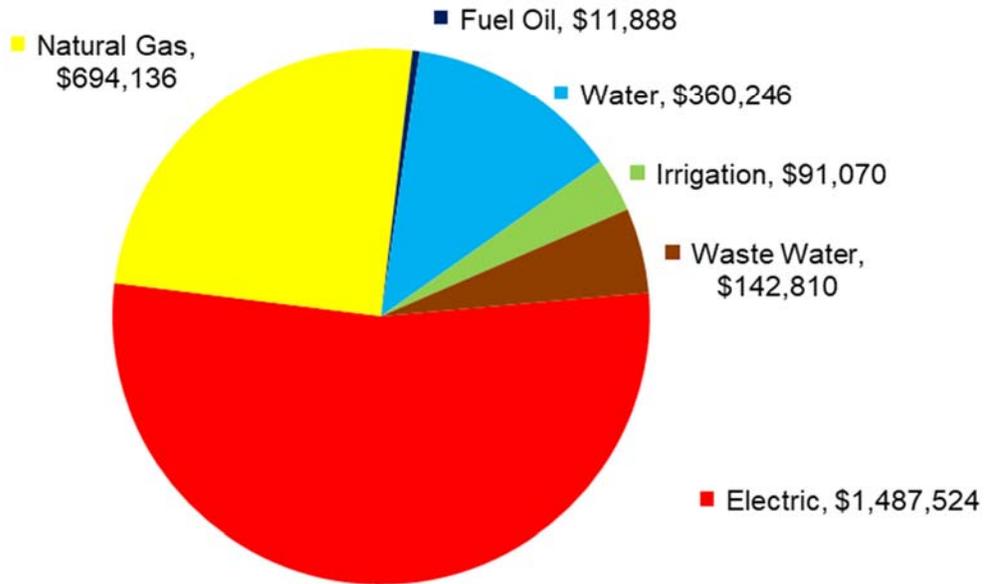
### CC 2019 Utility Cost Summary Total Cost \$2,787,675

- **For the 2019 academic year, Colorado College’s main campus energy related characteristics were:**
  - Approximately 2,264,533 square feet (SF) of space
  - Approximately 100 acres of land
  - 155 Buildings

- **For the 2019 academic year, Colorado College’s main campus energy performance statistics were:**
  - Energy use averaged **80.0 kBtu per square foot (SF)**
    - 5.3% increase over previous year
    - 6.6% of electricity from renewable sources
  - Energy costs averaged **\$0.97 per SF**
    - 6.6% increase over previous year
    - \$6.6M in avoided costs since 2008
  - MTCO<sub>2</sub> emissions from energy use averaged **0.0072 MTCO<sub>2</sub>e per SF**
    - 14.3% decrease over previous year
    - 36.6% decrease since 2008

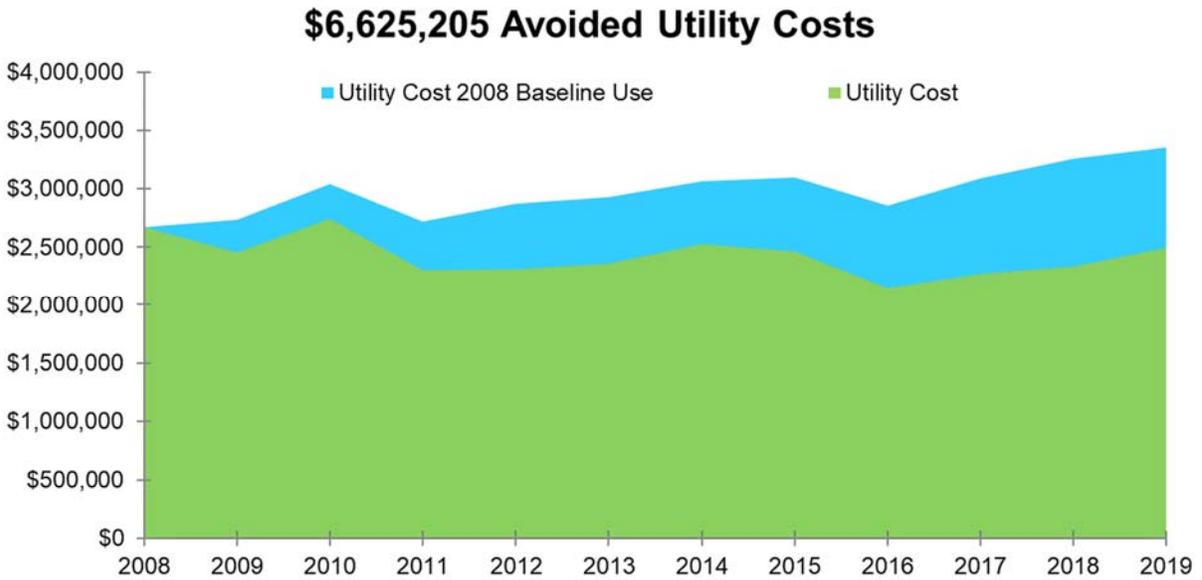
The cumulative campus utility cost avoidance compared to the campus baseline of 2008 is estimated at \$6.6M. The avoided cost for the 2019 academic year is estimated at \$857K. These numbers reflect combined utility savings, which include avoided electricity, natural gas, water, and waste water costs. Below is a graphical representation of overall avoided utility costs (area in blue).

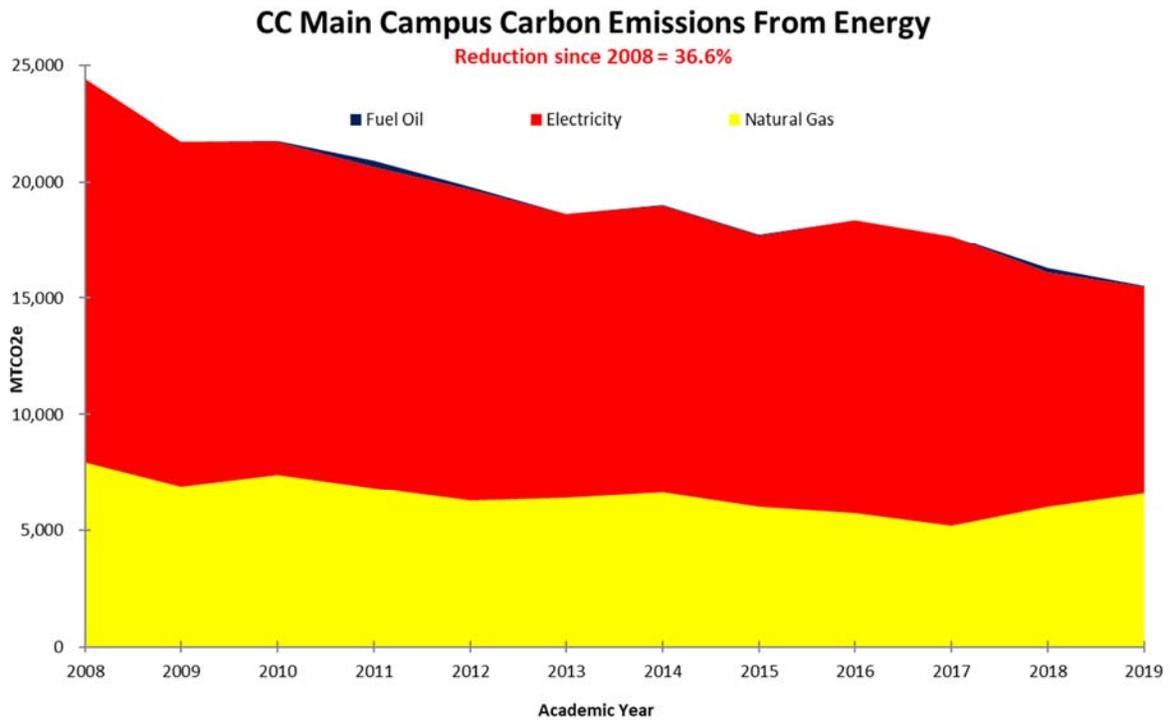
Colorado College’s commitment to become carbon neutral stems from the college’s signing of the Presidents’ Climate Commitment in early 2009. The college’s carbon footprint, in 2008, from energy use is estimated at 24,437 metric tons of CO<sub>2</sub> (MTCO<sub>2</sub>). Since 2008, Colorado College has made steady progress toward its carbon neutrality commitment. For 2019, the College’s carbon emissions from energy use are estimated at 15,500 MTCO<sub>2</sub> for a reduction of 36.6% compared to the 2008 baseline. The past 2 years carbon emissions decreased due to renewable energy credits and carbon offsets acquired to compensate for the additional carbon footprint of the Fine Arts Center. These measurements assume a consistent Colorado Springs Utilities (CSU) fuel mix and include emissions as charted below:

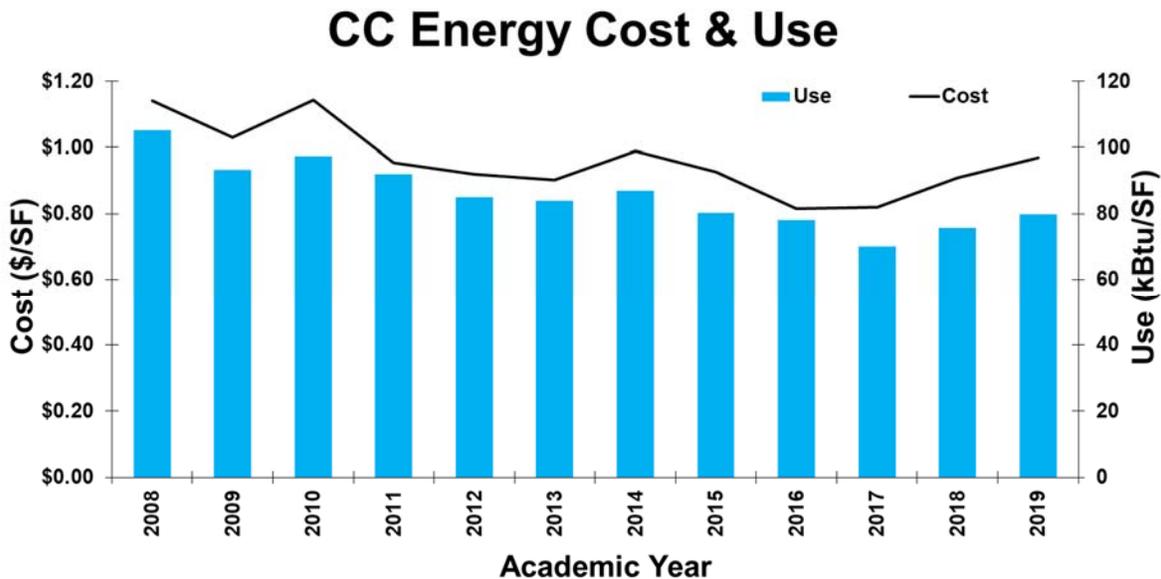
Colorado College has closely monitored and documented overall campus energy and cost intensity since 2008. For reference, the Association of Physical Plant Administrators (APPA), who represents the largest international association of educational institutions and their facilities departments, list the 2018 average energy intensity for higher education facilities at 97 kBtu/SF/Yr. APPA lists the average utilities cost per square foot at \$2.19 / SF. The chart below illustrates that CC’s performance exceeds both figures with an average energy intensity of 80 kBtu/SF/Yr and energy cost of \$0.97/SF.

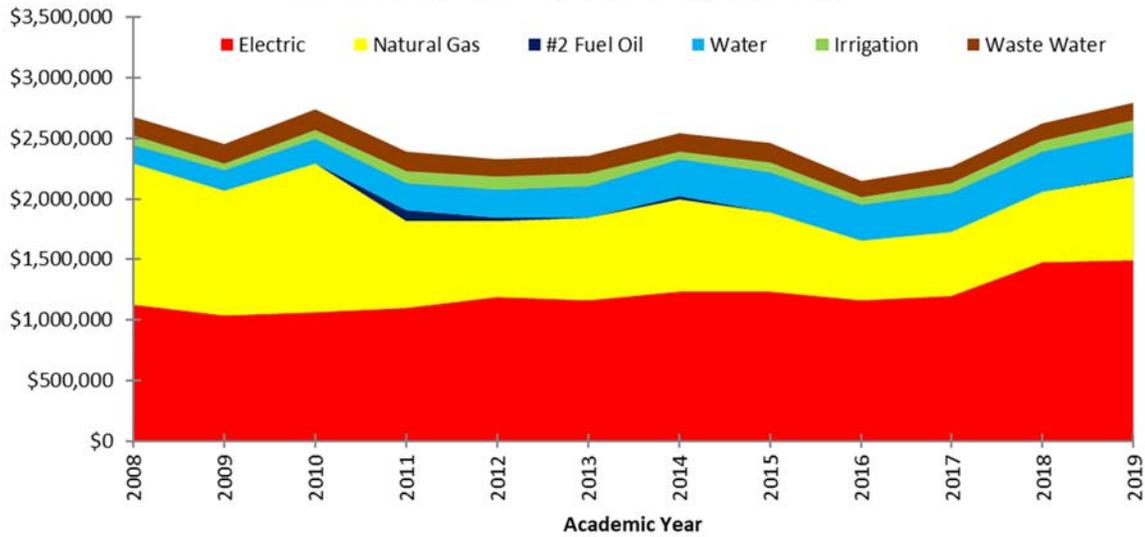
### CC Annual Utility Costs by Service

The chart above breaks down expenses by utility commodity. The most notable information is the continued increases in water and electricity rates. You will note large increases in 2018 energy consumption due to the addition of the Fine Arts Center at Colorado College. The charts below give more detail on these relationships.

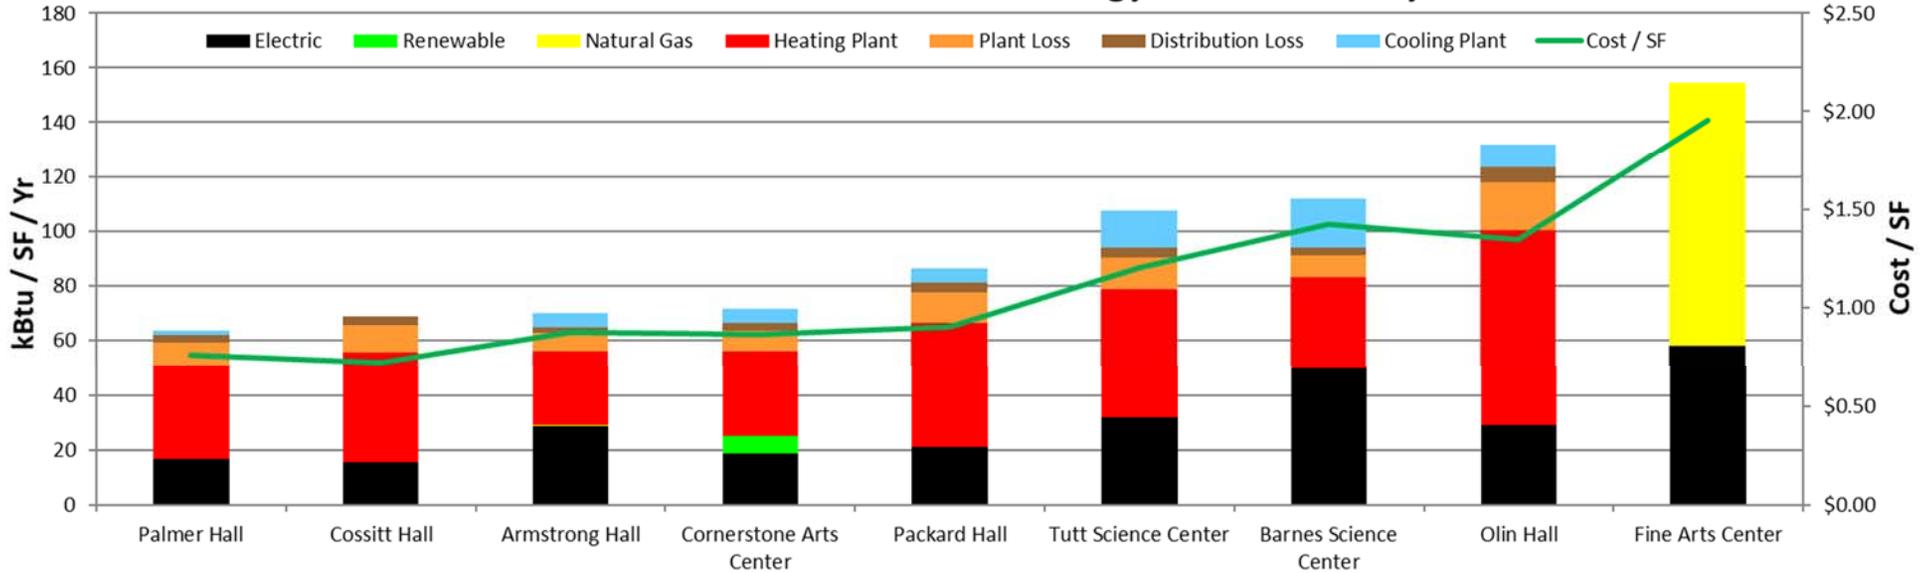
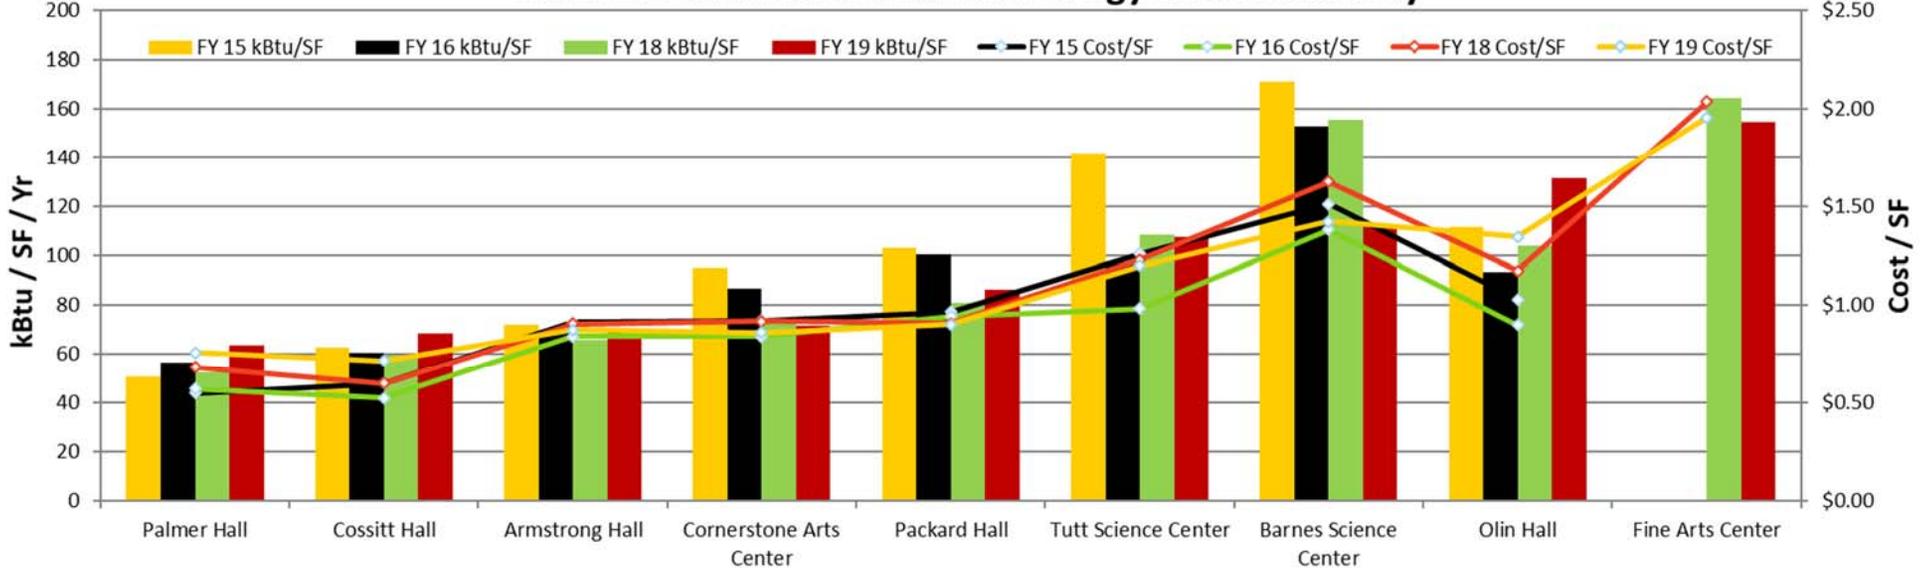
**CC 2019 Educational Facilities Energy & Cost Intensity**

This is the seventh year for energy benchmarking at the building level. In 2011, thermal metering was installed. Thermal metering has enabled CC to measure the amount of heating and cooling energy flowing from the central plant to respective buildings. The following charts are the result of building level thermal and electrical metering.

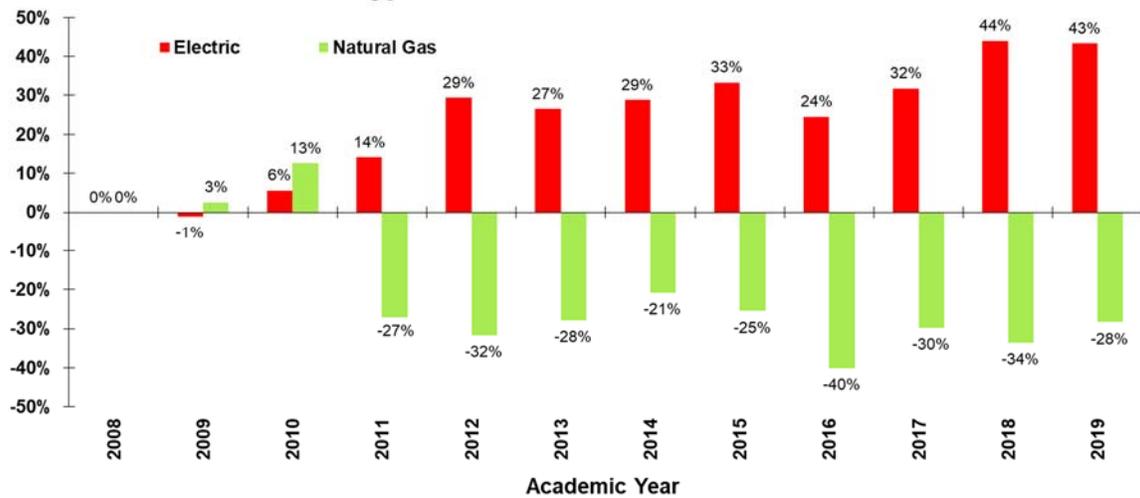
**CC Energy Rate Variation From 2008 Baseline**

CC has made significant improvements in reducing utility consumption since 2008. Because of these improvements, total costs are relatively unchanged even with increases in most utility rates. The charts below show the variation in commodity rates per unit experienced by CC since 2008. Electricity and water rate increases have seen larger than expected upward pressure. Natural gas costs have declined due to market conditions.

For the 2019 academic year the campus experienced a 7.3% increase in natural gas rates over the previous year. Water rates increased by 4.8% for potable water and 9.4% for non-potable water over the 2018 academic year. On January 1, 2020 we are expecting Colorado Springs Utilities to change rates as follows:

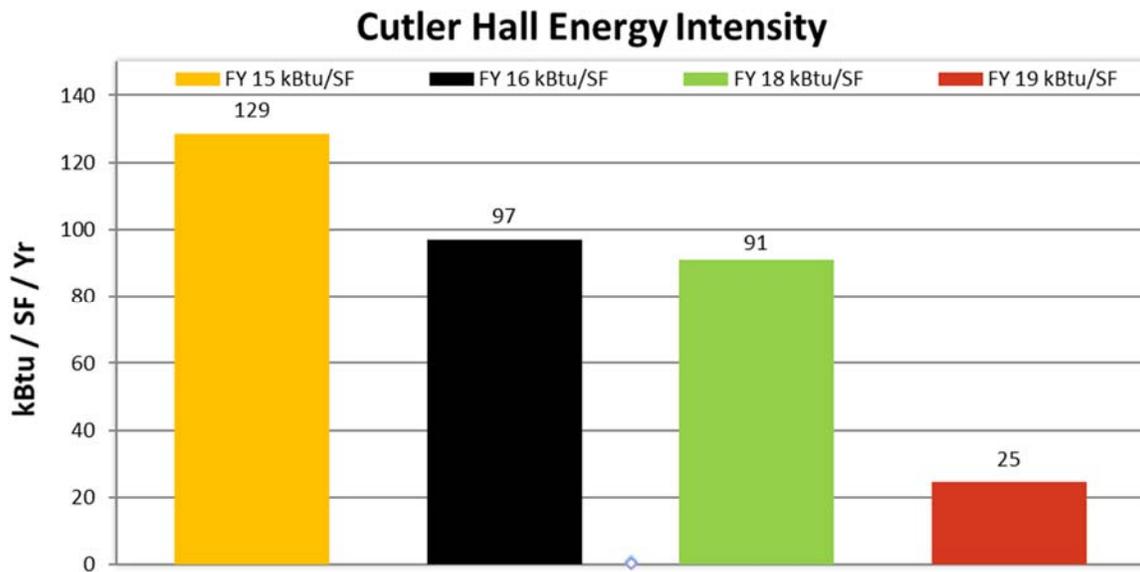
Project Description: This project commissioned the new HVAC system to ensure it performed as designed and satisfied occupant needs. The new system replaced a steam heating and ventilation system and added air conditioning at Cutler Hall. The previous system did not have good zone control, so as a result occupants were often too hot or too cold. The new system utilizes a new variable refrigerant flow heat pump system to maximize occupant comfort and efficiency while maintaining the historic characteristics of the building. The chart below illustrates actual energy performance at Cutler Hall of 25 kBtu/SF/Yr.

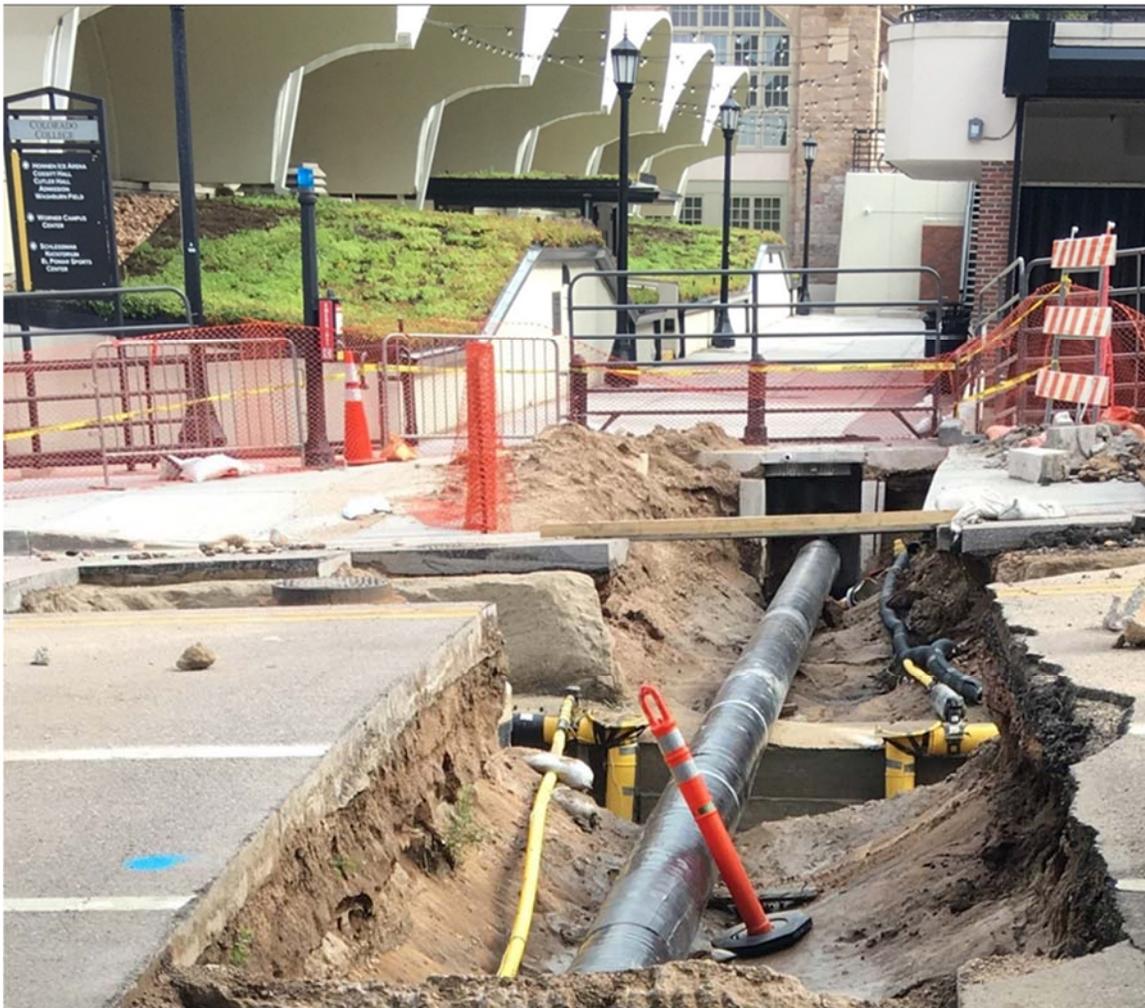
Project Description: This project replaced failing HTHW piping servicing Packard Hall from Worner Center across Cache La Poudre Street to Packard Hall. A new gas service was installed to Packard Hall. New HTHW piping is triple wall construction with a life expectancy of 50 years.

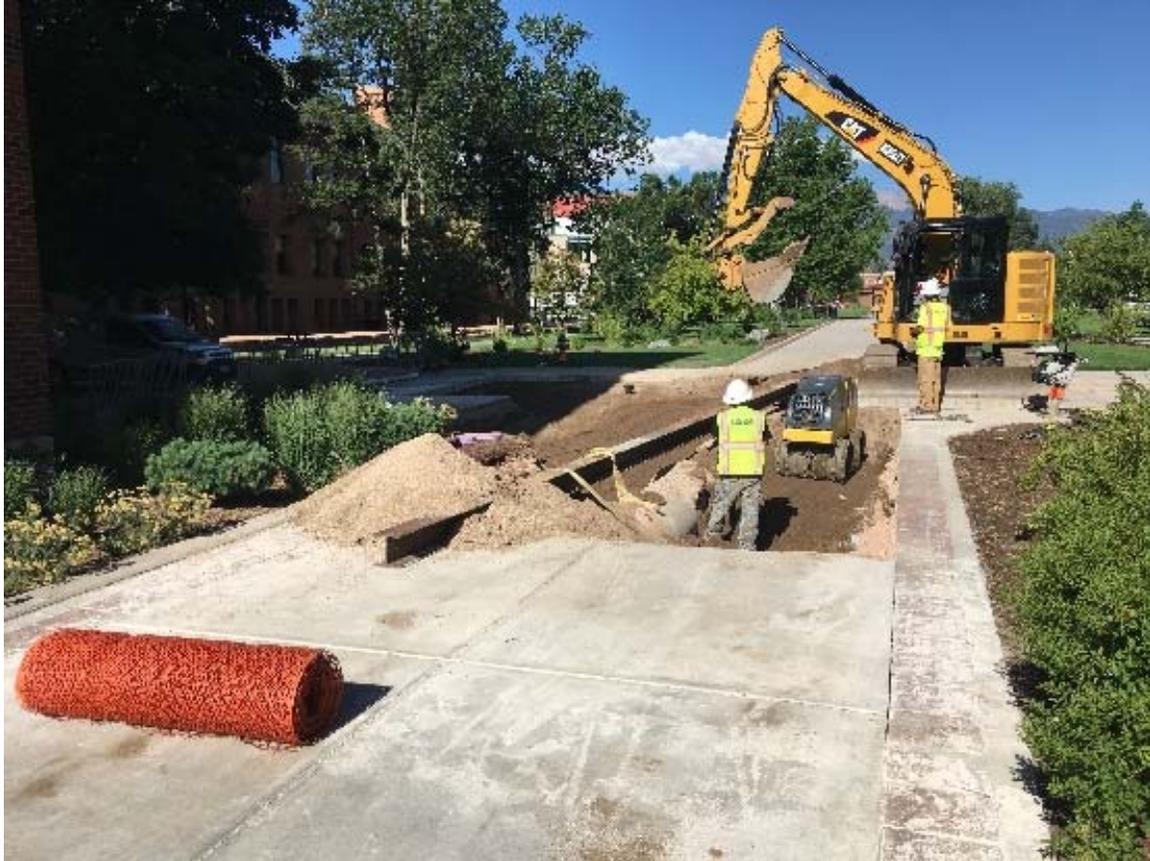
Project Description: The Barnes water main repair project repaired a water main servicing Barnes Science Center. The repair was difficult due to the pipe being below the academic walk, which includes a hydronic snowmelt system, storm drainage, and campus HTHW lines. The repair was completed with an extremely short outage utilizing a temporary service connection.

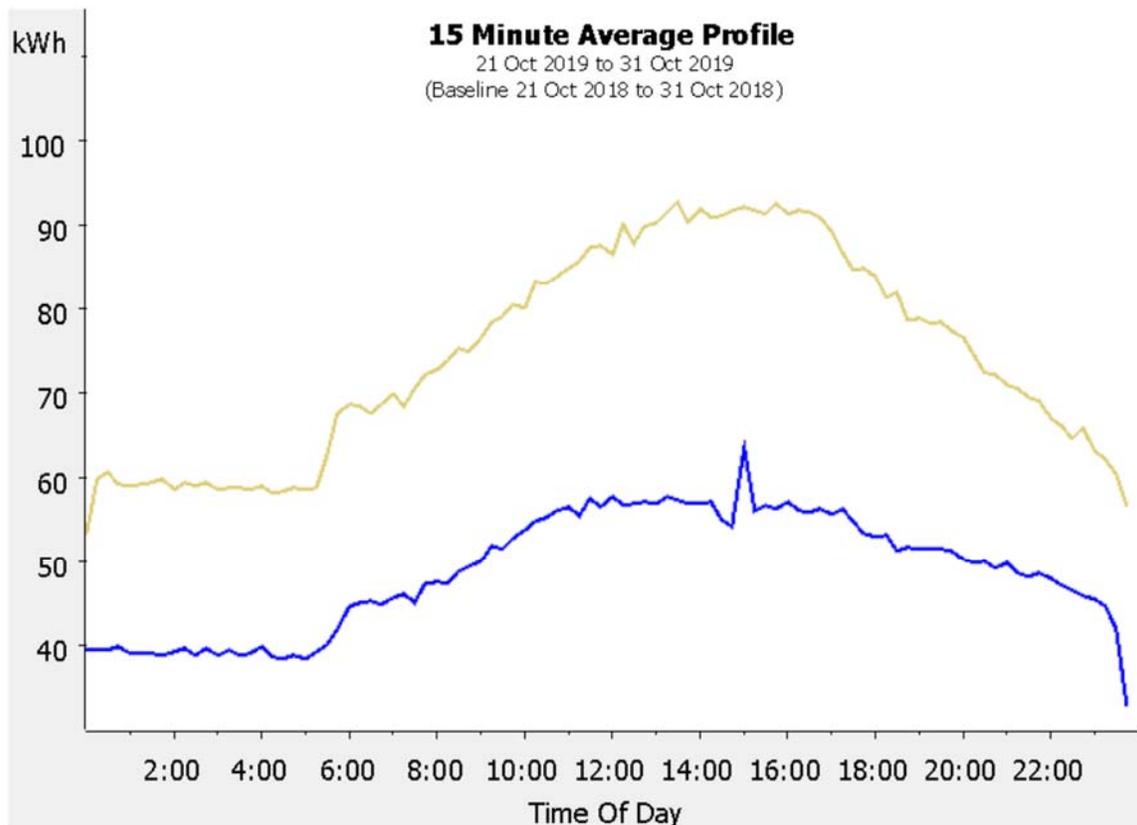
Project Description: The Fine Arts Center chiller replacement project replaced the facility’s main chiller improving the buildings reliability and efficiency. Due to the need for cooling and dehumidification to maintain special collection, the chiller is required to run year round and during low ambient temperature conditions. This has caused the existing chiller to fail prematurely due to short cycling. The new chiller incorporates free cooling to provide cooling during low ambient temperature conditions without a compressor improving efficiency. The chart below compares the Fine Arts Center average daily electrical profile for 10 days of operation last year (gold line) to the same period this year (blue line). It shows a significant reduction from the LED lighting upgrades and the chiller replacement project.
