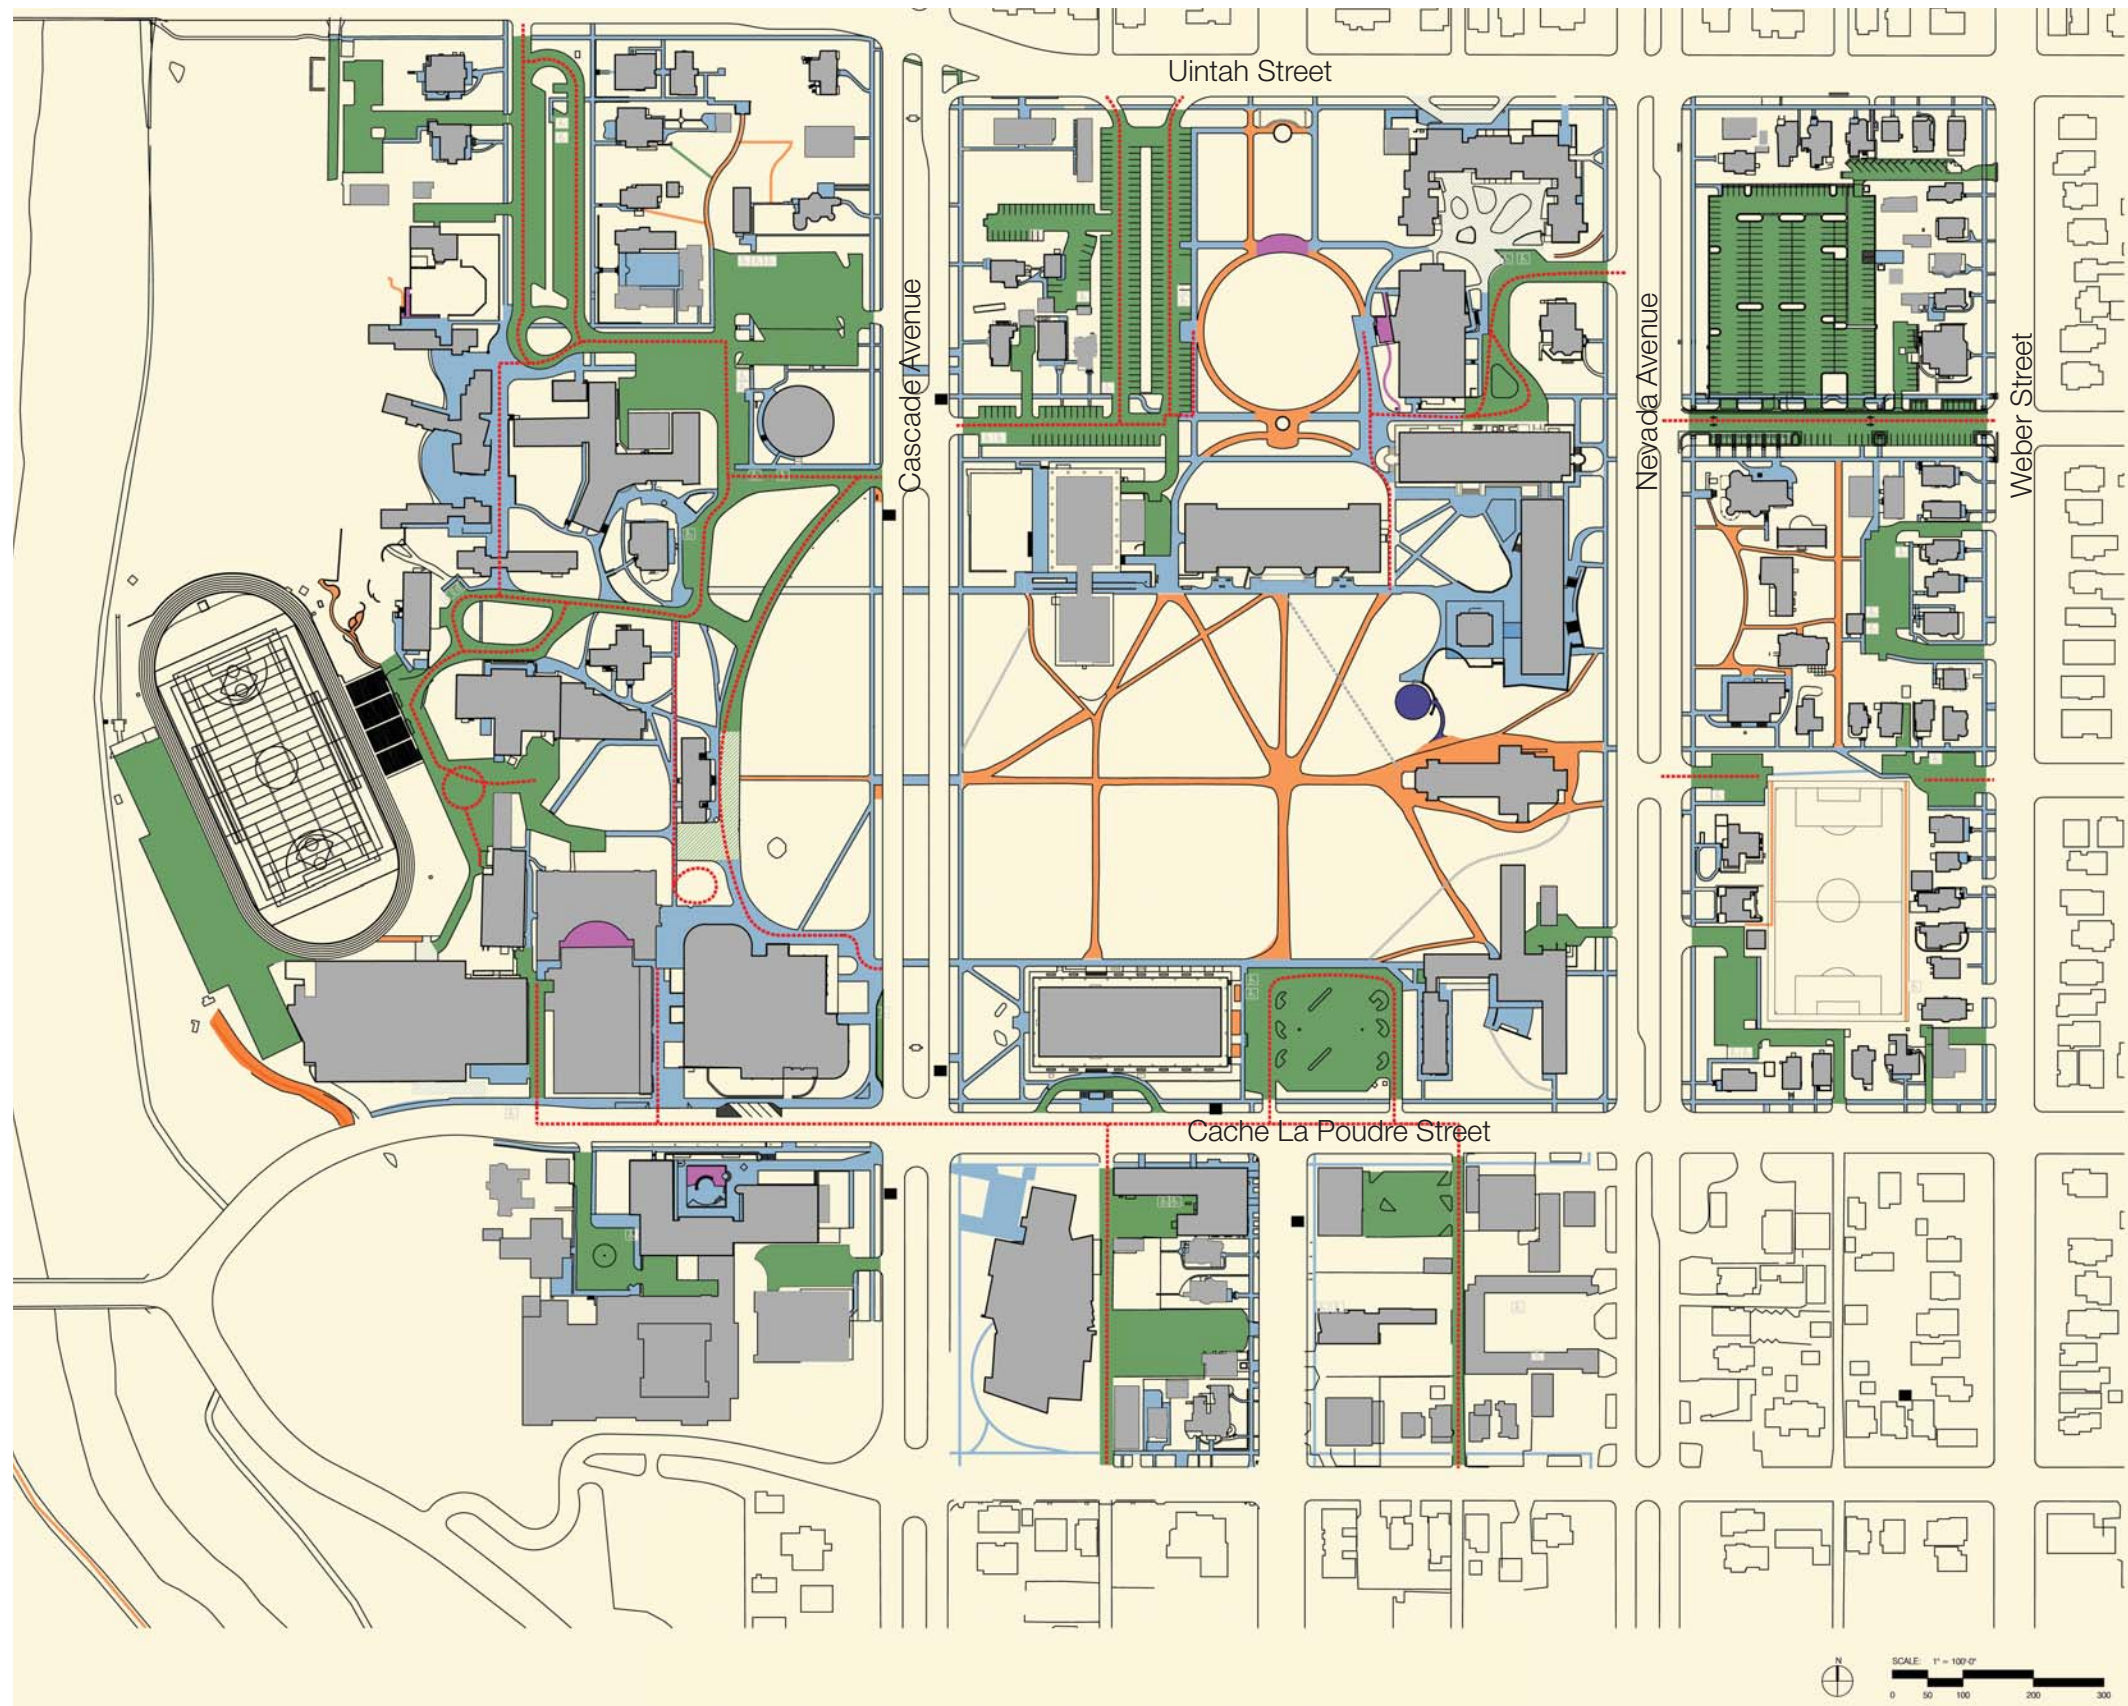
- Existing Concrete
- Existing Crusher Fines
- Existing Asphalt
- Existing Unit Pavers
- Existing Emergency Route
- Existing Social Path
- Existing Concrete, deteriorated
- Existing Stone
- Existing Asphalt, deteriorated

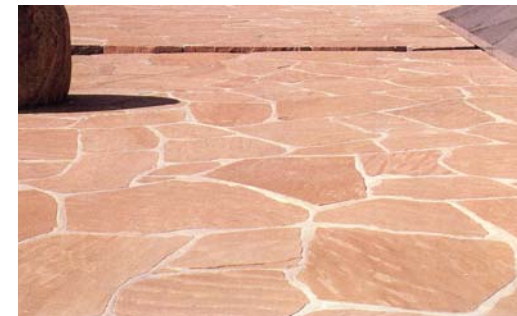
B Sandstone - Random Mosaic Pattern

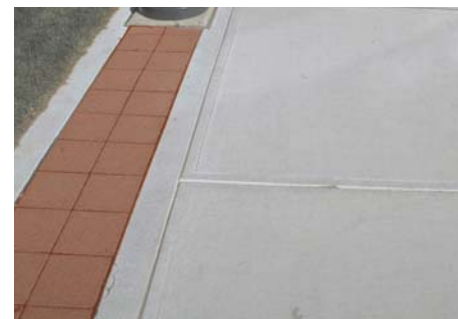
Concrete with Stone Banding

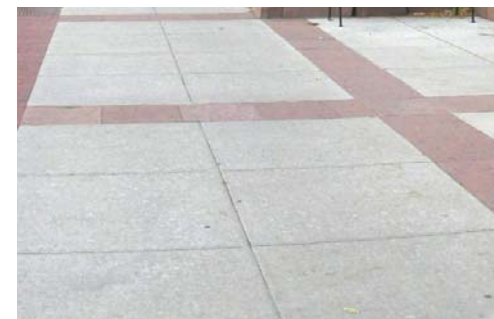
Concrete with Interval Stone Banding

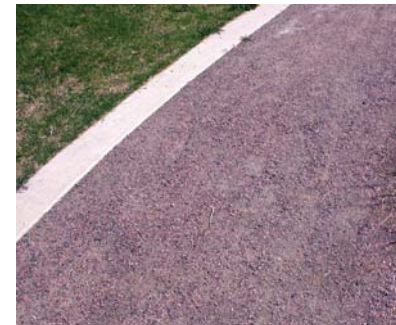
Stabilized Aggregate

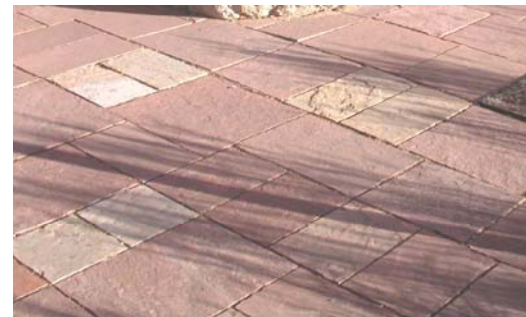
A Sandstone - Ashlar Pattern

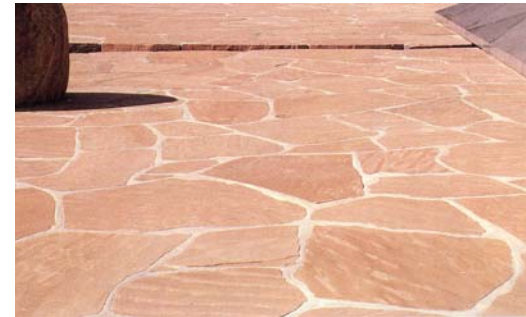
B Sandstone - Random Mosaic Pattern

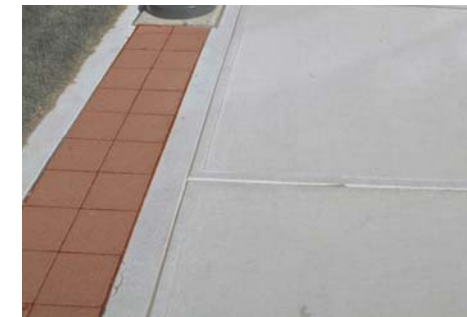
C D Concrete with Stone Banding

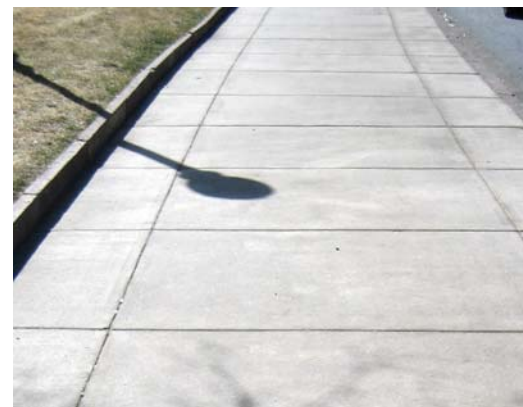
A Concrete with 1' Band

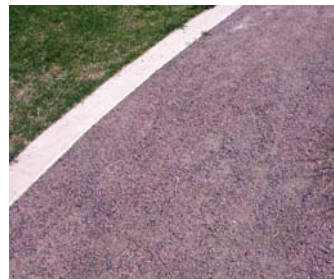
B Stabilized Aggregate
